RE: SKYLINE MINES - WATER MANAGEMENT REPORT

SKYLINE MINES

Water Handling Schematic

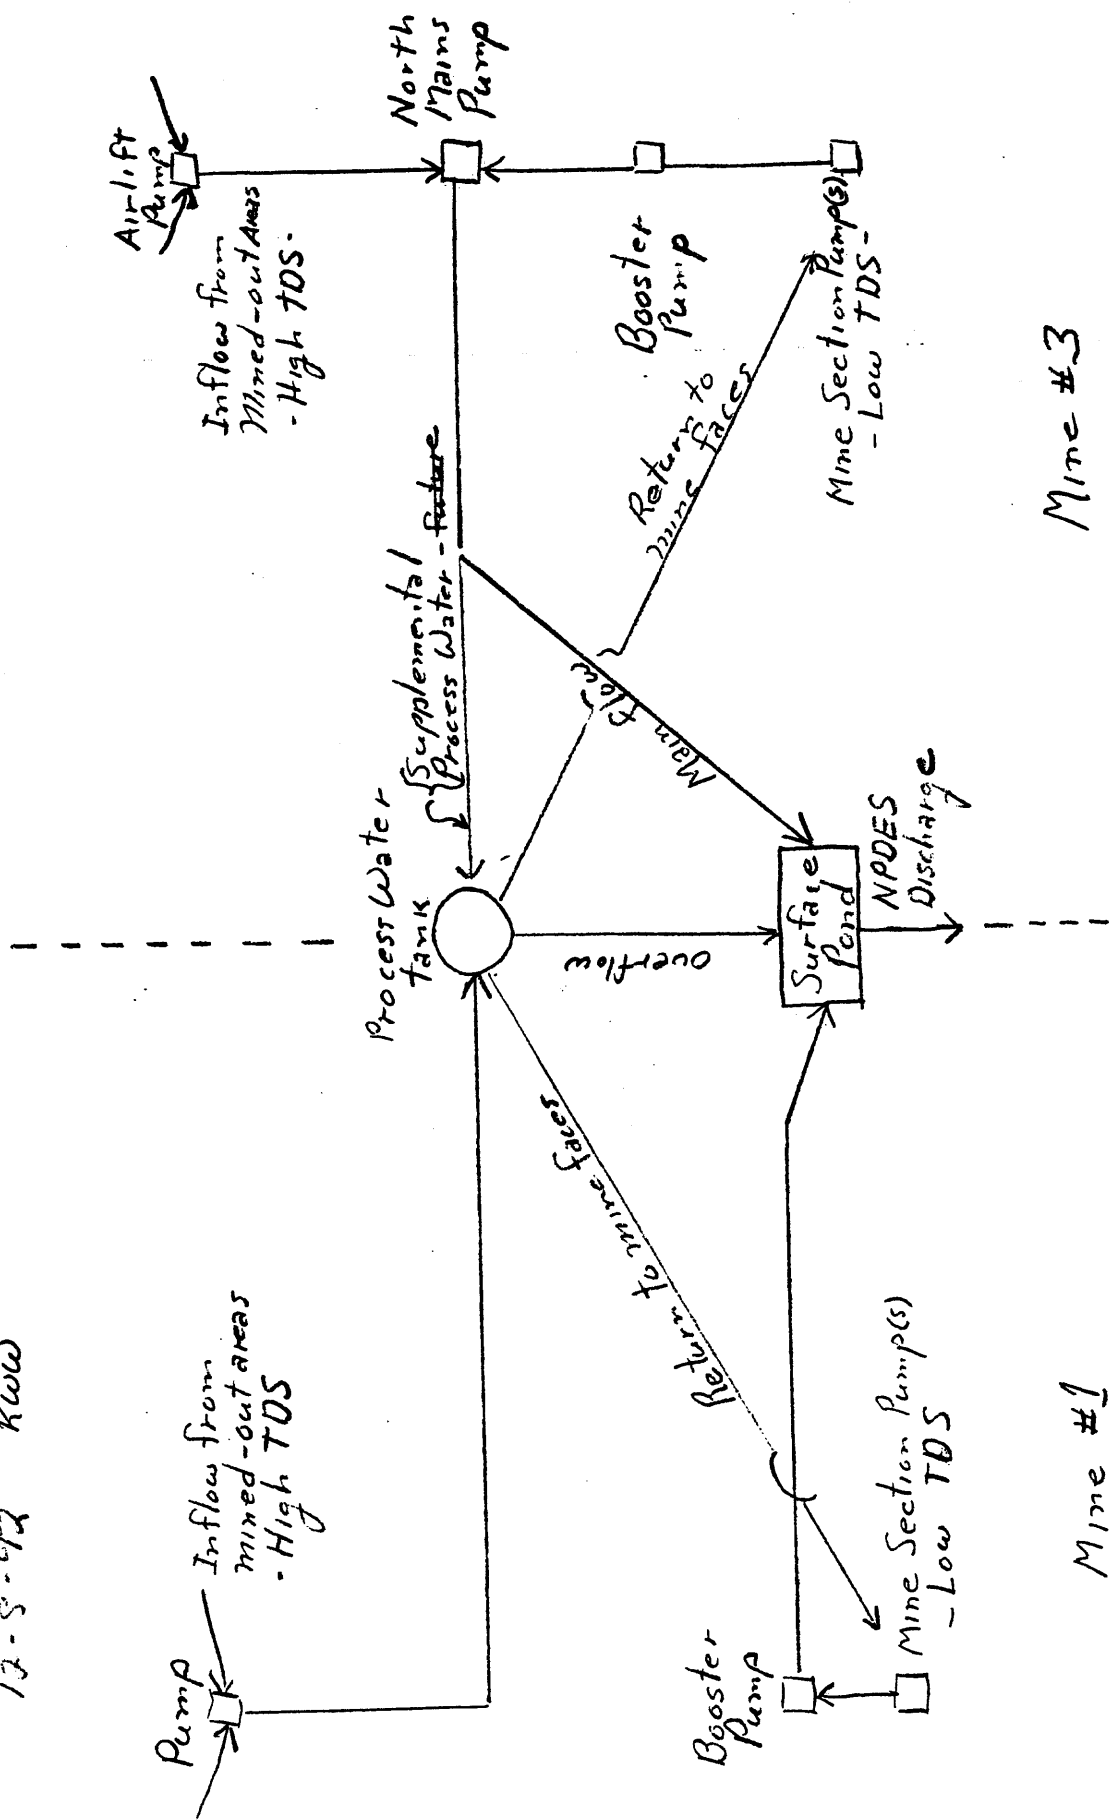
- An attempt was made to control the water level in a high TDS contribution area known as the North Mains Sump (see attached schematic diagram). Stabilizing the water level helps reduce the amount of re-entrained rockdust.
